River and lake health 2005–06

Rainfall and river flows 2005–06

Groundwater 2005–06

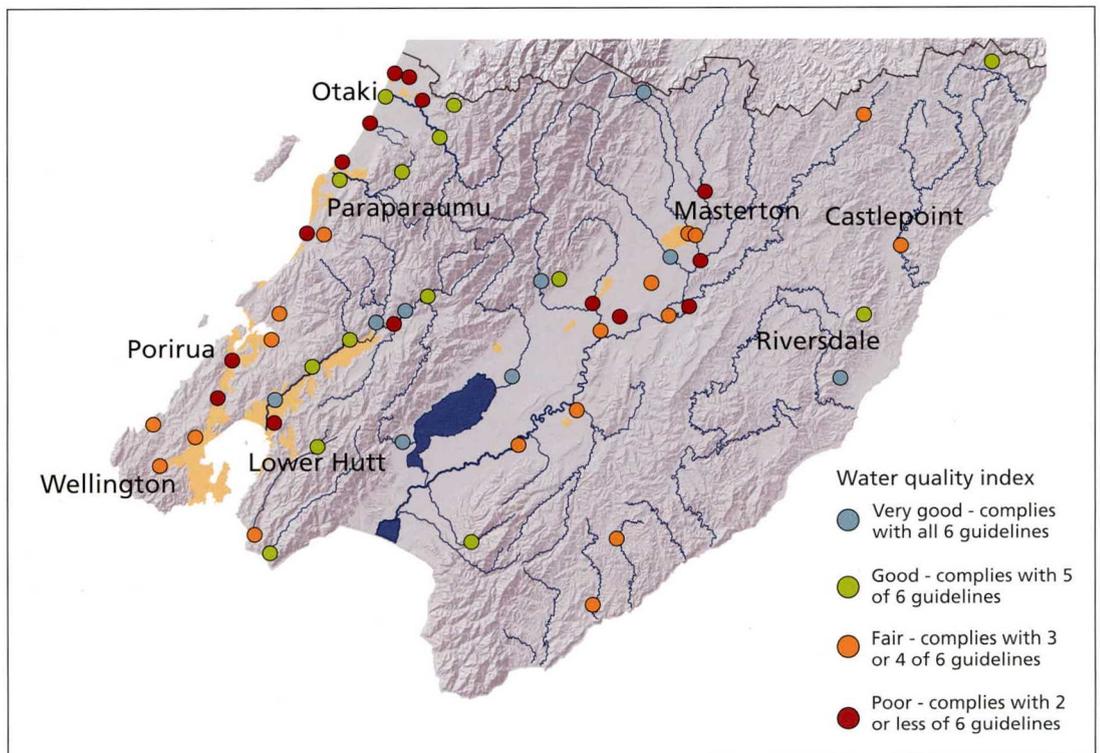
We can get a rough picture of how good the water quality is by checking the level of compliance with guidelines for six water quality indicators (water clarity, dissolved oxygen, dissolved reactive phosphorus, nitrite-nitrate nitrogen, ammoniacal nitrogen and *Escherichia coli*). The water quality index ratings here are based on two years' data from July 2004 to June 2006.

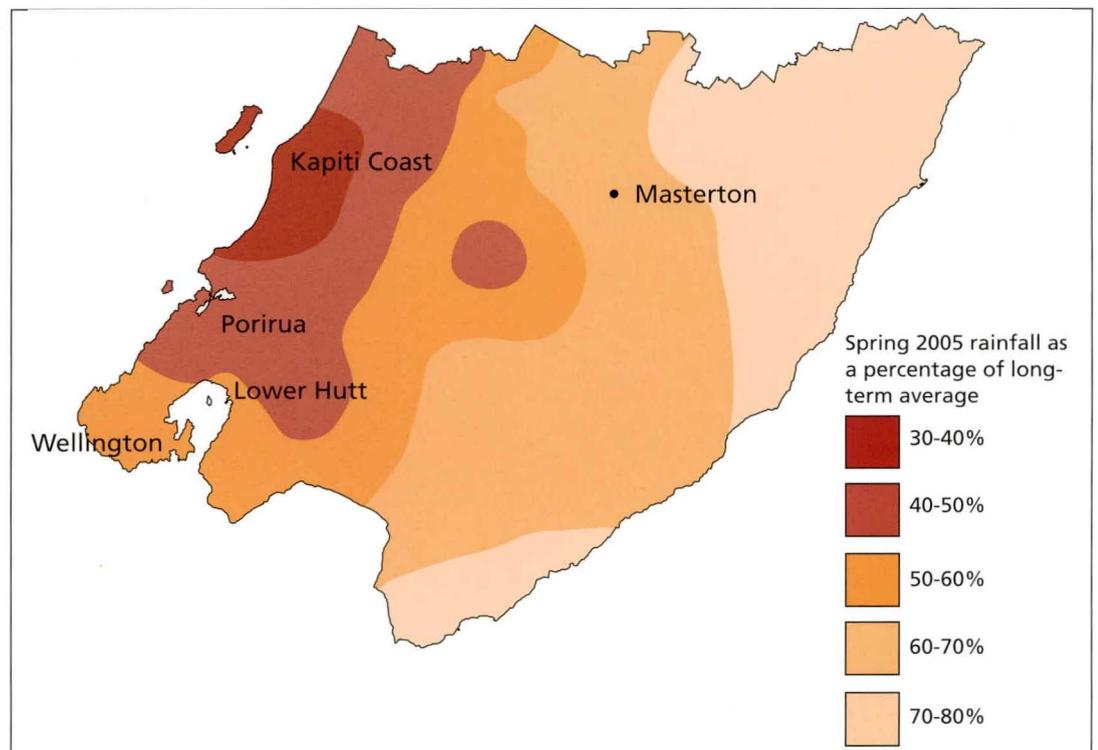
Rainfall received during Spring 2005 (September-November) as a percentage of the long-term average spring rainfall. The map shows that in the west of the Wellington region rainfall was less than half the amount expected for the time of the year, and in some places it was as low as 30% of normal.

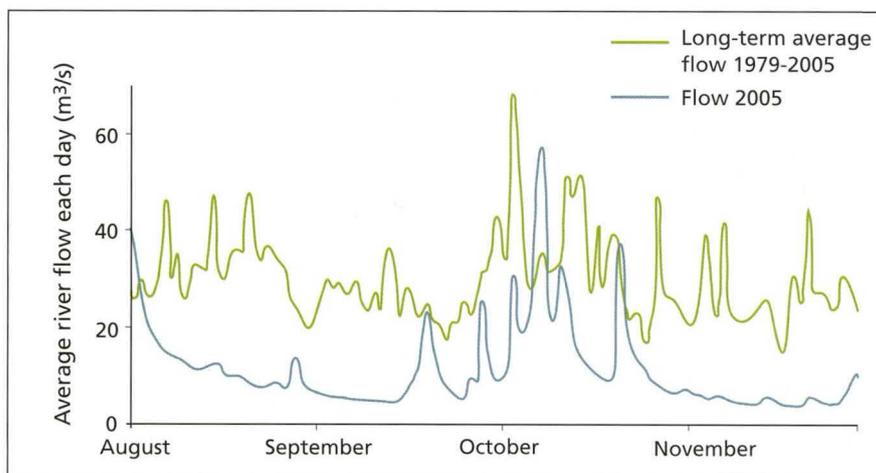
River flows in the Hutt River at Taita Gorge during August to November 2005. The blue line indicates the actual flow measured during winter and spring 2005; the green line shows the long-term mean flow for each day.

During spring 2005 the weather was unusually stable, and so the rivers experienced fewer 'freshes' than normal. The graph (right) shows that river flows in the Hutt River were well below average and more stable than normal, particularly during August, September and November. The lack of high river flows to 'flush' the river meant that thick mats of algae were able to develop in many rivers.

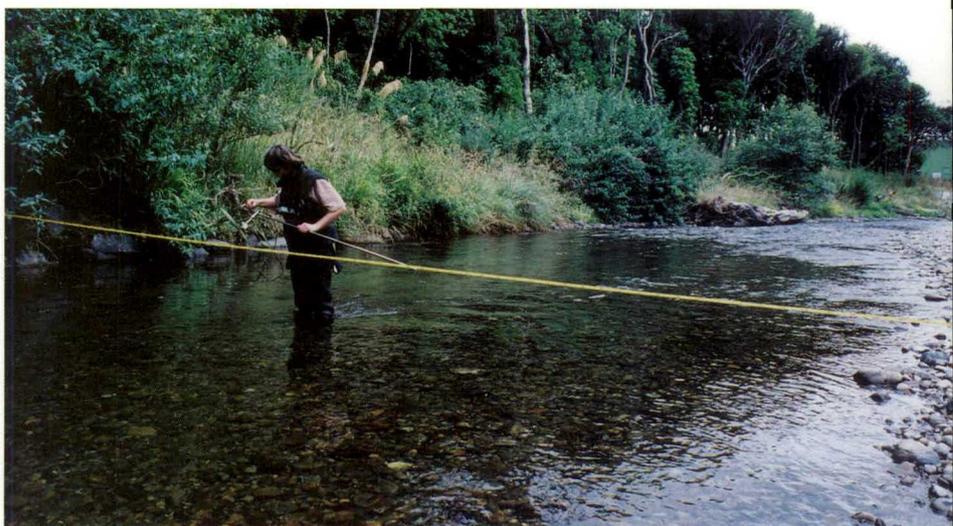
Greater Wellington staff measuring flows in the Waikanae River. We did this at about ten places along the river upstream from Waikanae to find out how much water was leaking between the river and groundwater. Both the river and the aquifer are used for water supply and we need to know the relationship between them so we can work out how much water it is safe to take.

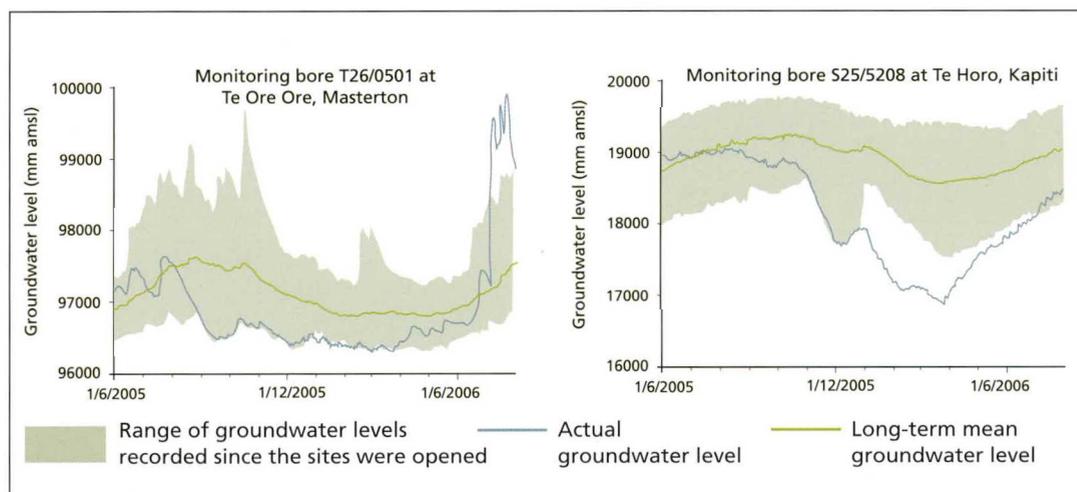
Groundwater levels around Masterton, which had been at record lows since winter 2005, stayed low throughout summer before reaching record highs in July 2006 after the prolonged rain in the Wairarapa. In Kapiti, record low levels at the beginning of summer 2006 fell even lower in spring and stayed low into winter.

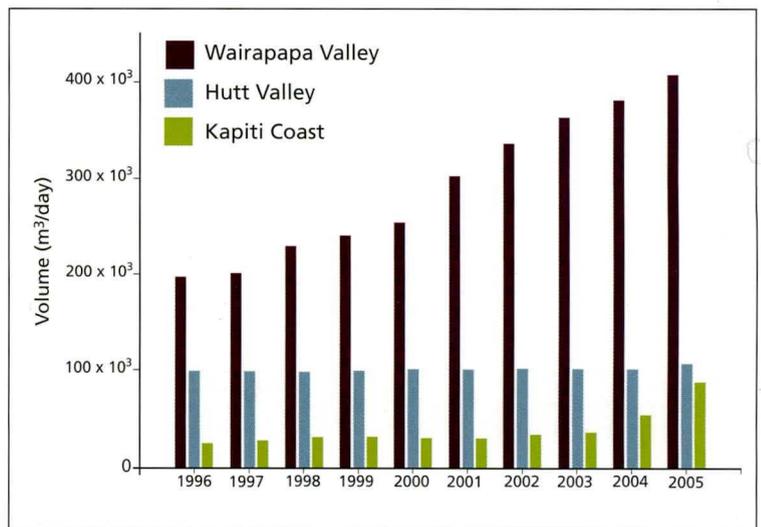
Irrigation demand in the Wairarapa has led to more and more water being taken from Wairarapa groundwater resources.

Greater Wellington has authorised a substantial increase in groundwater use in the region over the last 10 years. Most of this increase has been in the Wairarapa, where a high demand for irrigation water has seen the allocated volume more than double from 200,000 cubic metres per day in 1996 to over 400,000 cubic metres per day today. Allocation in the Hutt aquifers has stayed at around 100,000 cubic metres per day over this time because the main aquifer system, the Lower Hutt groundwater zone, has been fully allocated (87% for public water supply) for a number of years. Increasing abstraction on the Kapiti coast – now approaching 100,000 cubic metres per day – is mainly to supplement Kapiti Coast District Council’s surface water abstraction for public water supply and is only used when water levels in the Waikanae River are too low to allow water to be taken.

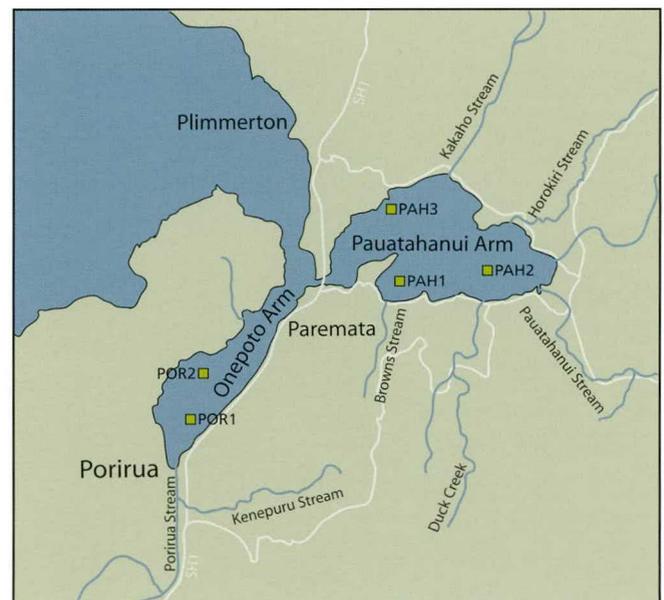
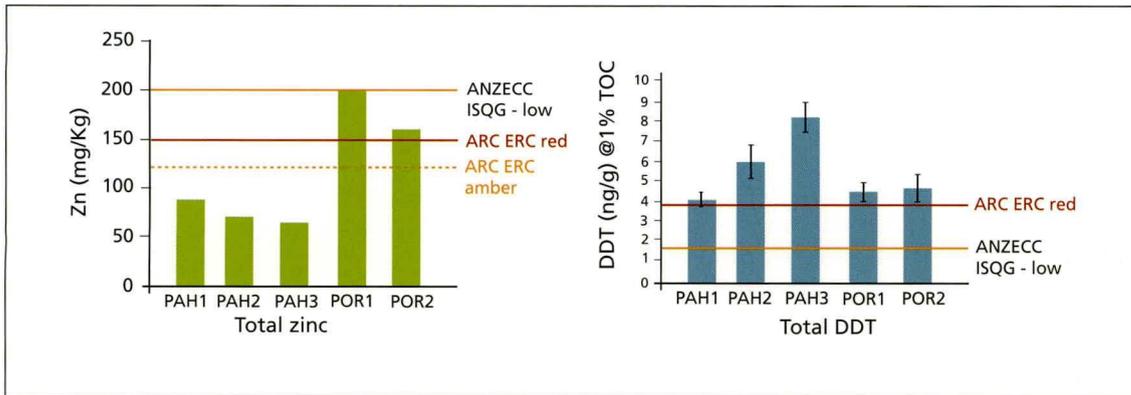
Total zinc and average total DDT concentrations recorded in sub-tidal sediments from the Porirua Harbour in October 2004. Guidelines indicating possible and probable adverse effects are shown in orange and red. Although DDT-based pesticides are no longer in use, recent studies of stream bed sediments and urban stormwater confirm that DDT contaminated soil is still getting washed into streams.

Scuba divers took samples of marine sediments at these five sites in Porirua Harbour so we could test them for heavy metals and other contaminants that persist in the environment for a long time. At each site the divers collected 25 sediment cores 50 mm diameter x 120 mm deep. The Pauatahanui Arm of the harbour, often called the Pauatahanui Estuary or Pauatahanui Inlet, is a regionally and nationally significant natural resource. It is classified as an area of significant conservation value in our Regional Coastal Plan, and as a site of special wildlife interest (SSWI) by the Department of Conservation.

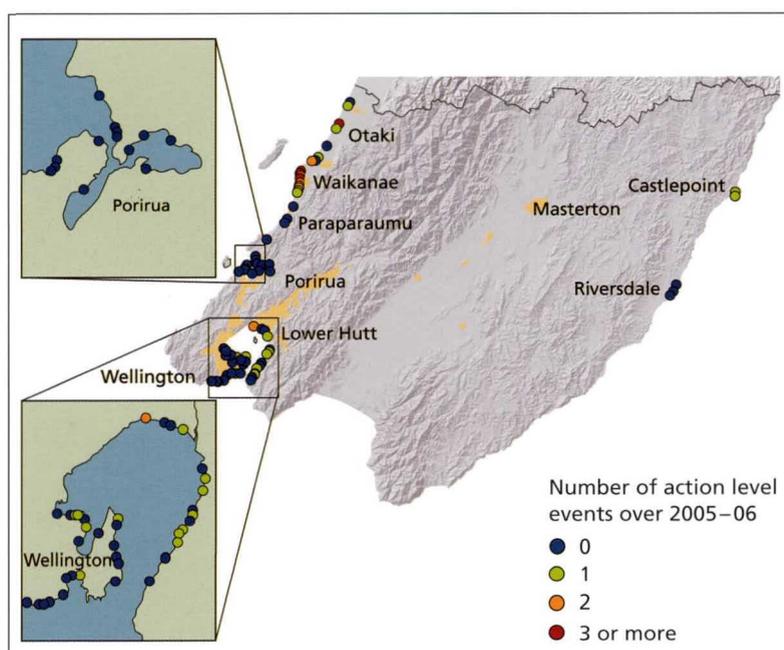
Summary of compliance with the recreational water quality guidelines for 76 marine bathing sites monitored over the 2005-06 summer. For up-to-date results about water quality over the summer bathing period, check our website at <http://www.gw.govt.nz/on-the-beaches>.

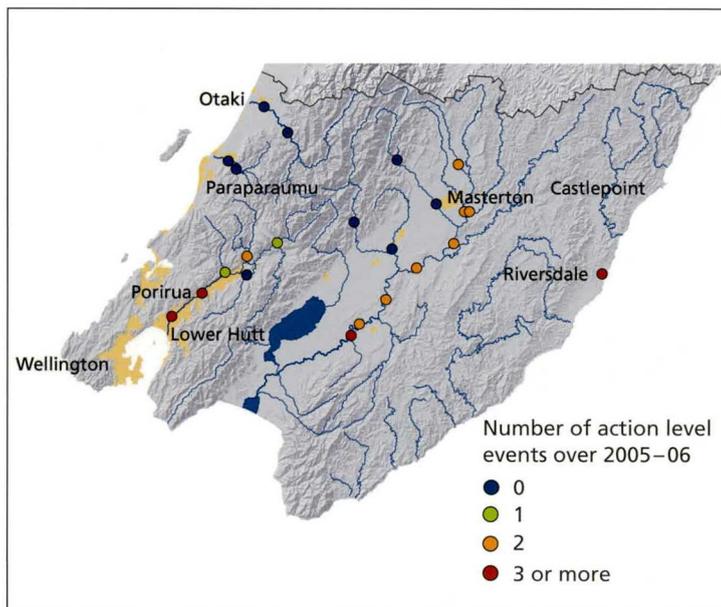
Summary of compliance with the recreational water quality guidelines for 23 freshwater bathing sites monitored over the 2005-06 summer.

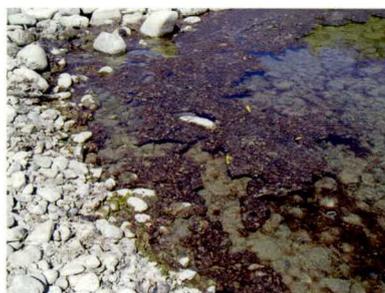
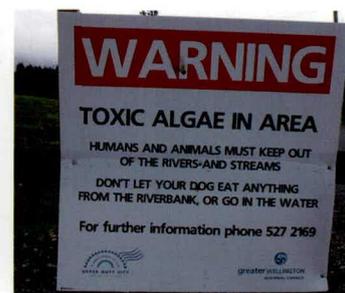
Cyanobacteria mats in the Hutt River at Melling Bridge, 18 November 2005. The presence of extensive cyanobacteria mats is linked with low river flows and warm weather (see Rainfall and river flows report card). These mats can grow even in clean or unpolluted rivers.

Early last summer we found mats of cyanobacteria (blue-green algae) in some reaches of the Otaki, Waikanae, Hutt and Waipoua rivers. Cyanobacteria can produce cytotoxins that can make people sick and fatally poison some animals - dogs can die within hours of eating even small amounts. Regional Public Health and the city and district councils put up health warning signs advising people to keep away from affected rivers in the region.

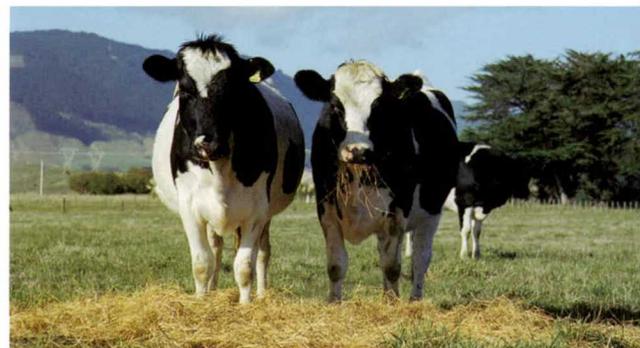
Our second round of soil monitoring showed that some soils under pasture are compacted. Soil compaction is a problem because the soil has less air spaces and so water and nutrients can't get through to the lower soil layers and pasture can't grow very well.

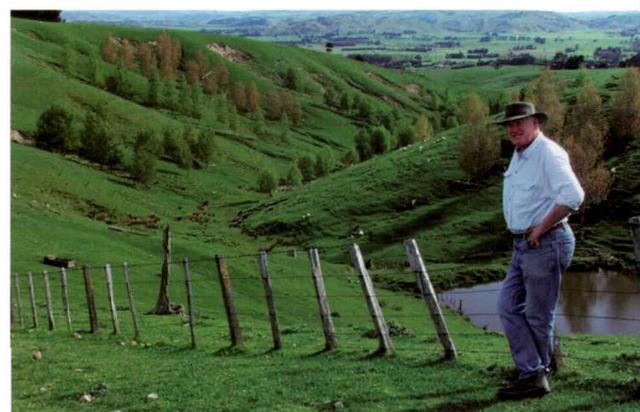
Poplars are used by many hill country farmers in the Wairarapa to stabilise erosion prone land. Without them, more soil would have washed off this farm in Pakaraka, near Masterton during the winter 2006 storms that hit on the property. Eroded hill sides can take more than 30 or 40 years to heal.

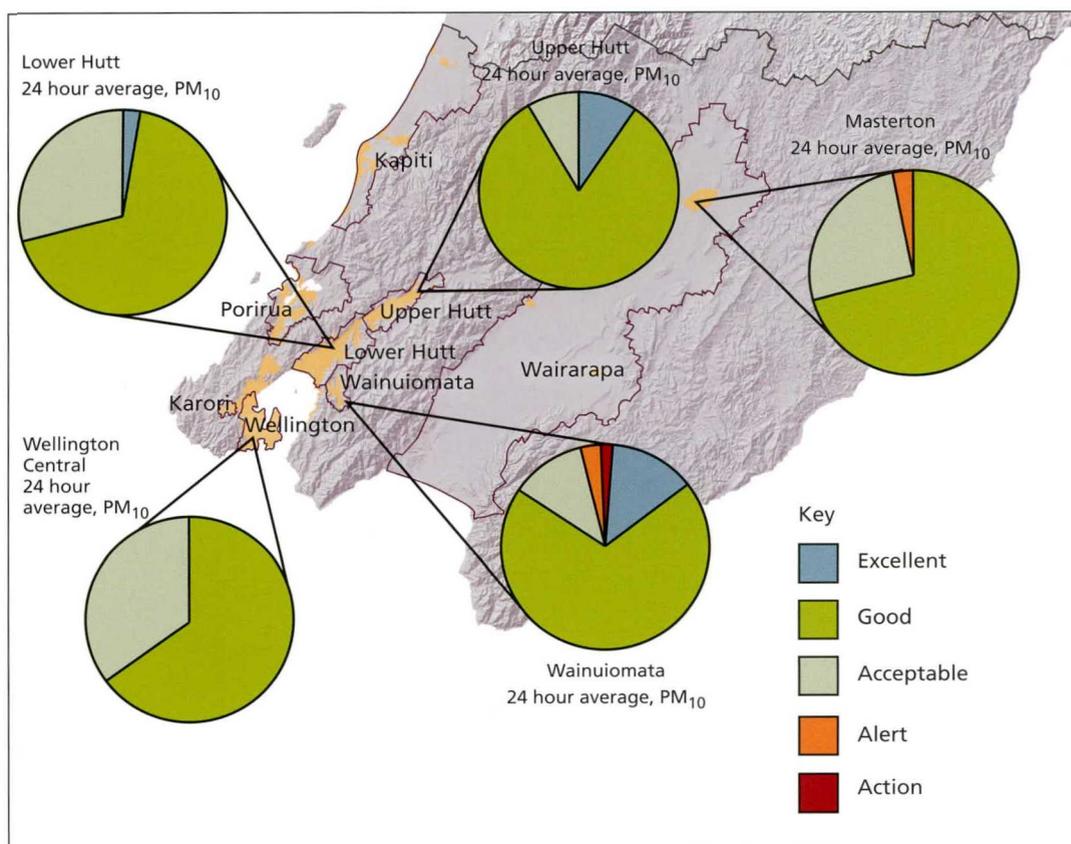
Figure 1: Levels of particulate matter (PM₁₀) in five of the region's airsheds as measured at our monitoring stations in central Wellington, Upper Hutt, Lower Hutt, Wainuiomata and Masterton over the last year to 30 June 2006.

On winter nights when people are burning wood or coal to heat their homes, fine particles discharged from their chimneys can build up in the surrounding air. On still, cold and clear evenings this polluted air is not dispersed until the morning when the air starts to move again.

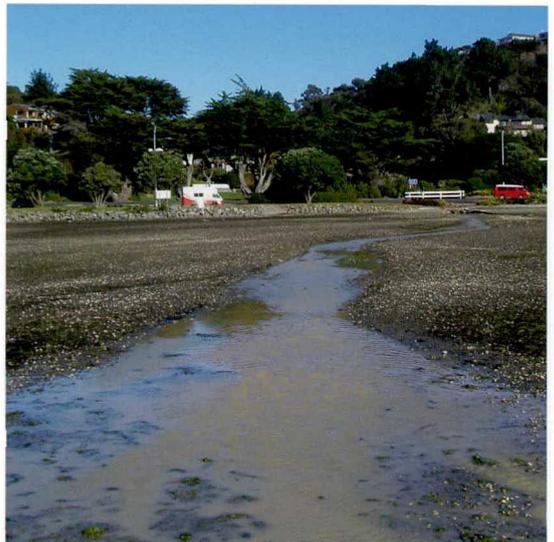
Sediment discharges from Staithes Drive, Whitby caused repeated discoloration at Browns Bay, Pauatahanui. After investigation of an earthworks site on Staithes Drive, we issued an abatement notice requiring them to cease further sediment discharges, improve erosion sediment control and reinstate the watercourse. We issued three infringement notices totalling \$1,750.
