Planning & Resources Department

**Motuwaireka Stream Targeted Investigation Study
Of Bacteriological Water Quality**

October 1999 – July 2000

Wellington Regional Council

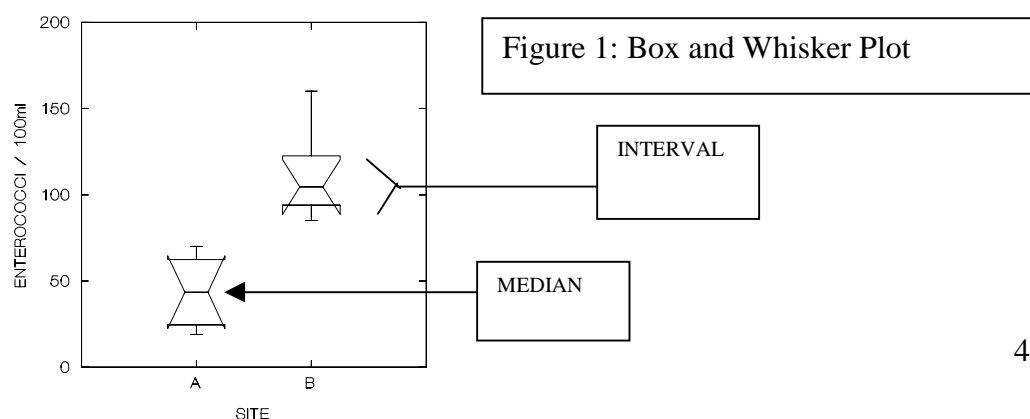
differences in respect to the box and whisker plots. A significant difference is detectable (with 95% confidence) if the confidence intervals around two medians do not overlap (McGill, Tukey, & Larsen 1978). This is illustrated diagrammatically on the previous page.

Figure 1 shows that site B has significantly higher *Enterococci* concentrations compared to site A. This is depicted by the intervals around the two medians not overlapping.

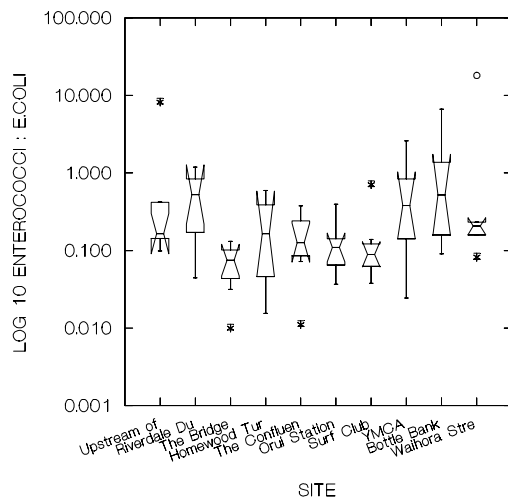
Figure 4: Box and whisker plots of the ratio of Enterococci to E. coli.

Figure 4 shows that the *Enterococci:Ecoli* ratio is generally higher at the Riversdale Dump, YMCA and Bottle Bank sites.

The Riversdale Dump, YMCA and Bottle Bank sites generally show high *Enterococci* / *E.coli* ratios. This indicates that these sites represent a more continuous source of contamination compared to the other sites. Appendix 3 shows photographs of exuding leachates from the Riversdale Tip entering a tributary of the Motuwaireka Stream.

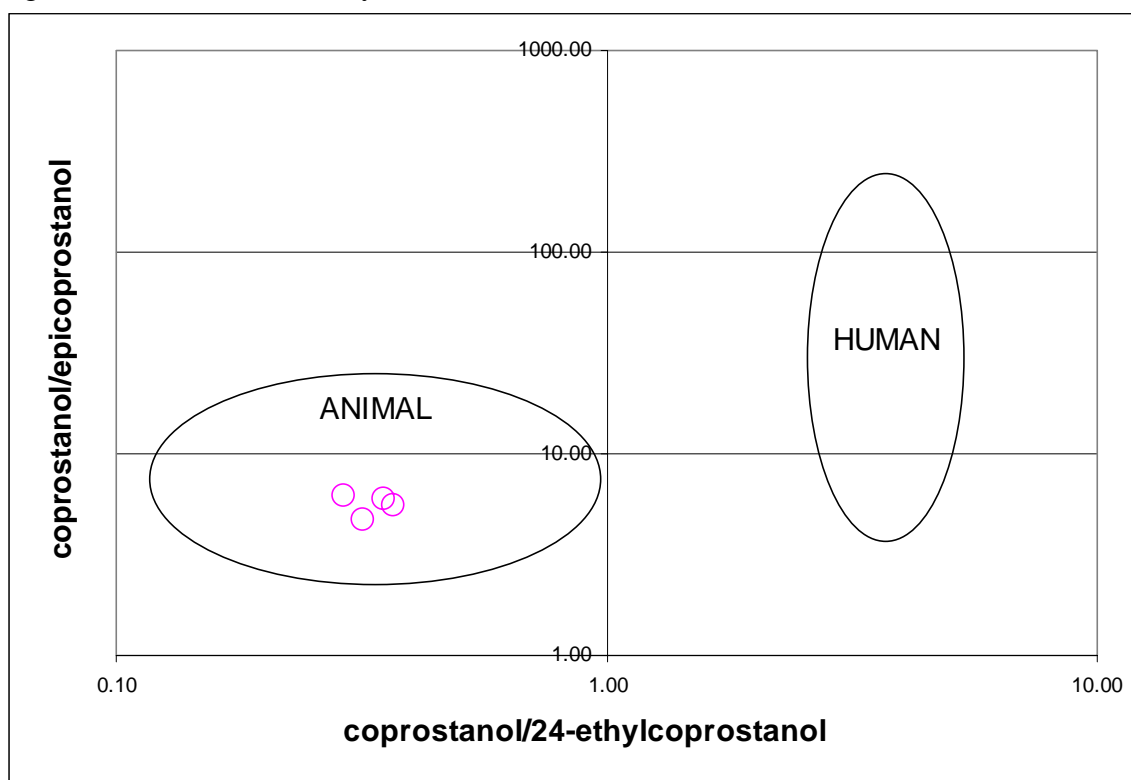
Figure 5: Faecal Sterol Analyses

The faecal sterol analyses performed by ESR indicate that the faecal contamination within the Motuwaireka Lagoon is predominantly of animal origin (see reference letter in Appendix 4). Note that the ellipses placed around the data points do not imply statistical confidence limits, they simply represent areas in which the data points commonly fall.

The faecal sterol analysis indicates that the bacterial contamination within the lower reaches of the Motuwaireka Stream is of predominantly animal origin.
