Report 01.06

Report to Landcare Committee
from Steve Murphy, Operations Engineer, Flood Protection Group

Willow Sawfly in the Wellington Region

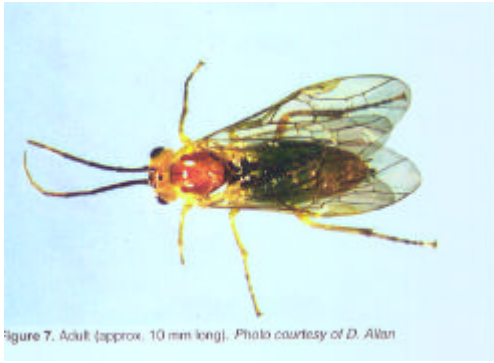
Figure 7. Adult (approx. 10 mm long). Photo courtesy of D. Allan

Adult sawflies lay their eggs in small cuts made in willow leaves. The emerging larvae feed on the leaves until the cocoon stage when they pupate into an adult fly. The length of the life cycle is dependent on environmental conditions, but in laboratory tests averaged about 35–40 days. Numerous life cycles are therefore possible before the insect over winters in the soil or leaf litter. With few if any natural enemies, and a ready supply of willows, the insect has tremendous population potential.

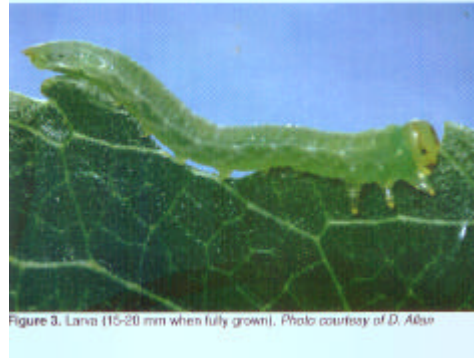
Figure 8. Larva (15-20 mm when fully grown). Photo courtesy of D. Allan
