Porirua Harbour

Sediment Monitoring 2012/13

Prepared
for
**Greater
Wellington
Regional
Council**
June
2013

Leigh Stevens and Barry Robertson

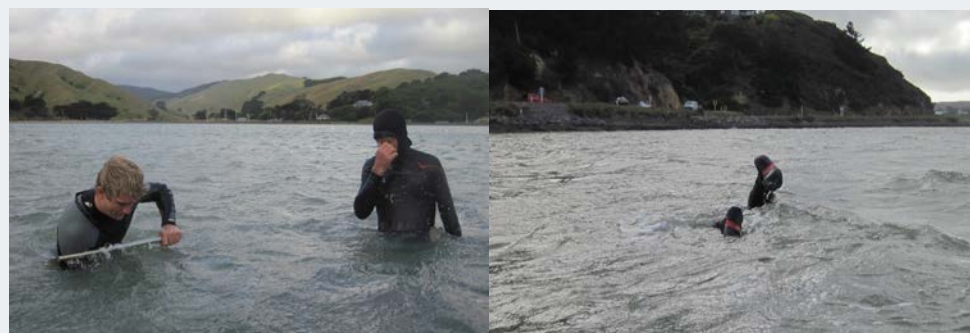
Installing and checking subtidal plates in the Pauatahanui Arm, January 2013.

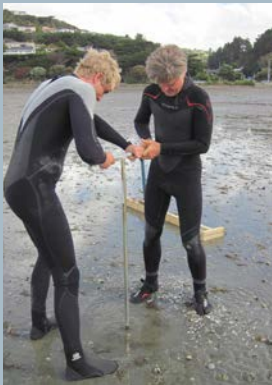
Installing and levelling a sediment plate in Browns Bay, January 2013.

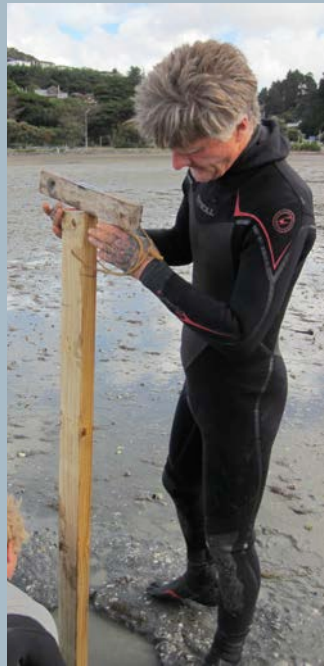
Measuring frame and probe used to measure shallow subtidal plates.

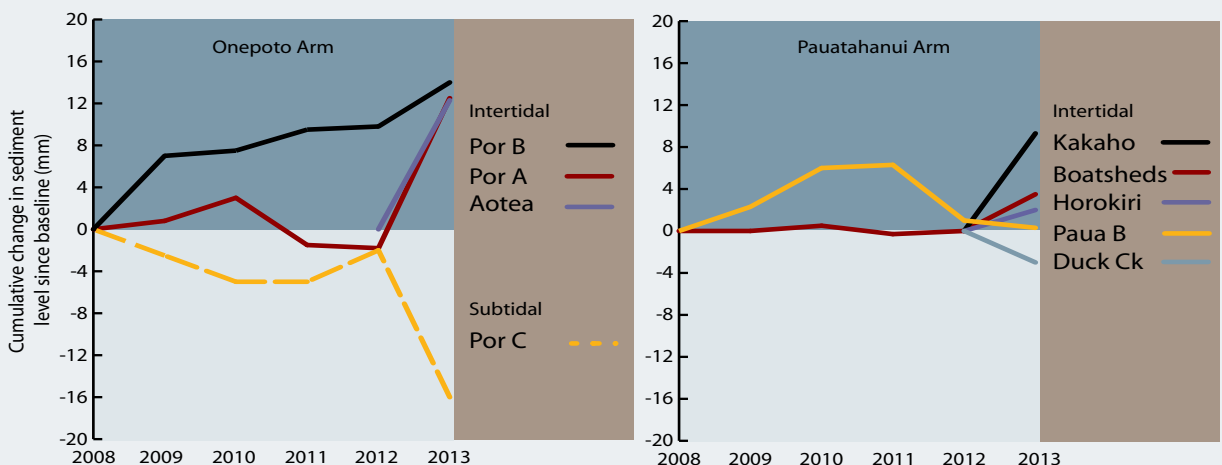
Mean annual sedimentation rates from baseline measures to 2013 range from -3.2 to +12.3mm/yr (Table 1). Such rates fall within the “very low” to “very high” condition ratings. The greatest measured cumulative intertidal deposition is in the Onepoto Arm (Figure 2), the three sites classified as either “moderate” or “very high” (Table 1). The subtidal site (S9), for which multi-year measures are available, showed sediment erosion. In Pauatahanui Inlet, the intertidal sites established in 2008 had sedimentation rates in the “very low” category, while the three sites established in 2012 were rated “very low” (Duck Creek), “moderate” (Horokiri), and “high” (Kakaho). Monitoring over a longer period at these three sites is needed to determine the significance of the initial trends, particularly as wind driven waves have an obvious effect on intertidal sediments through localised resuspension and deposition.

Figure 2. Mean change in sediment showing trends over buried plates from 2008-2013.

Baseline measures for the nine new plate sites established in 2013 will be reported on after they are re-measured (next scheduled for January 2014). Ongoing annual monitoring of all plates for the next five years is recommended to assess the impacts of predicted land disturbance from proposed forest harvesting, urban development, and road construction in the catchment.
