WAIKANAE ESTUARY: 2021/2022 INTERTIDAL SEDIMENT MONITORING SUMMARY

Salt Ecology Short Report 015. Prepared by Leigh Stevens for Greater Wellington Regional Council, April 2022.

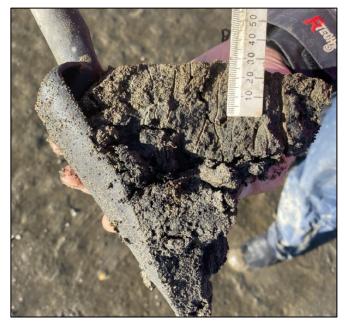
Example of well-oxygenated sediment at Site A.

The average aRPD depth (based on replicate measurements adjacent to each plate) ranged between 25 and 30mm at all sites in January 2022, a condition rating of 'good' (Table 3). This level of oxygenation is partially maintained by the presence of crabs and burrowing organisms in the surface sediments, which turn over surface sediments and create voids that allow air and water to transfer oxygen to underlying sediments (see adjacent photo).

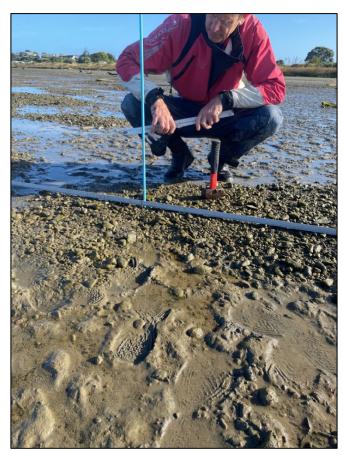
Mixed mud and gravel deposits at Site C.

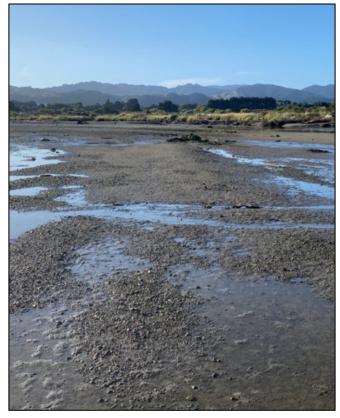
Ridges of gravel at Site B indicative of flood deposition.

At Site B, marker pegs could not be relocated as the site had been covered in a gravel deposit and sediment plate measurements could not be taken.

Table 3 presents the sediment grain size data for Sites A to C, with sites rated from 'very good' to 'fair' in 2022 and showing a reduction in mud content from 2021 consistent with flood scouring at Sites A and C, and the deposition of gravels at Site B. Over time, mud content has been variable at all sites with no consistent site-scale trends observed. However, across all years, the most upstream site (Site C) has been muddier than the two downstream sites (Sites A and B), suggesting preferential deposition and retention of fine muds in the upper estuary.
